## UNIT STATES ENVIRONMENTAL PROTECTION AGENCY

SUBJECT: Final Site Screening Study Plan for  
Chain of Rocks Amusement Park Site - St. Louis, MissouriFROM: William J. Keffer  
Chief, EP&R/ENSVTO: John C. Wicklund  
Director, ENSVNAME OF SITE: Chain of Rocks  
St. Louis County, Missouri

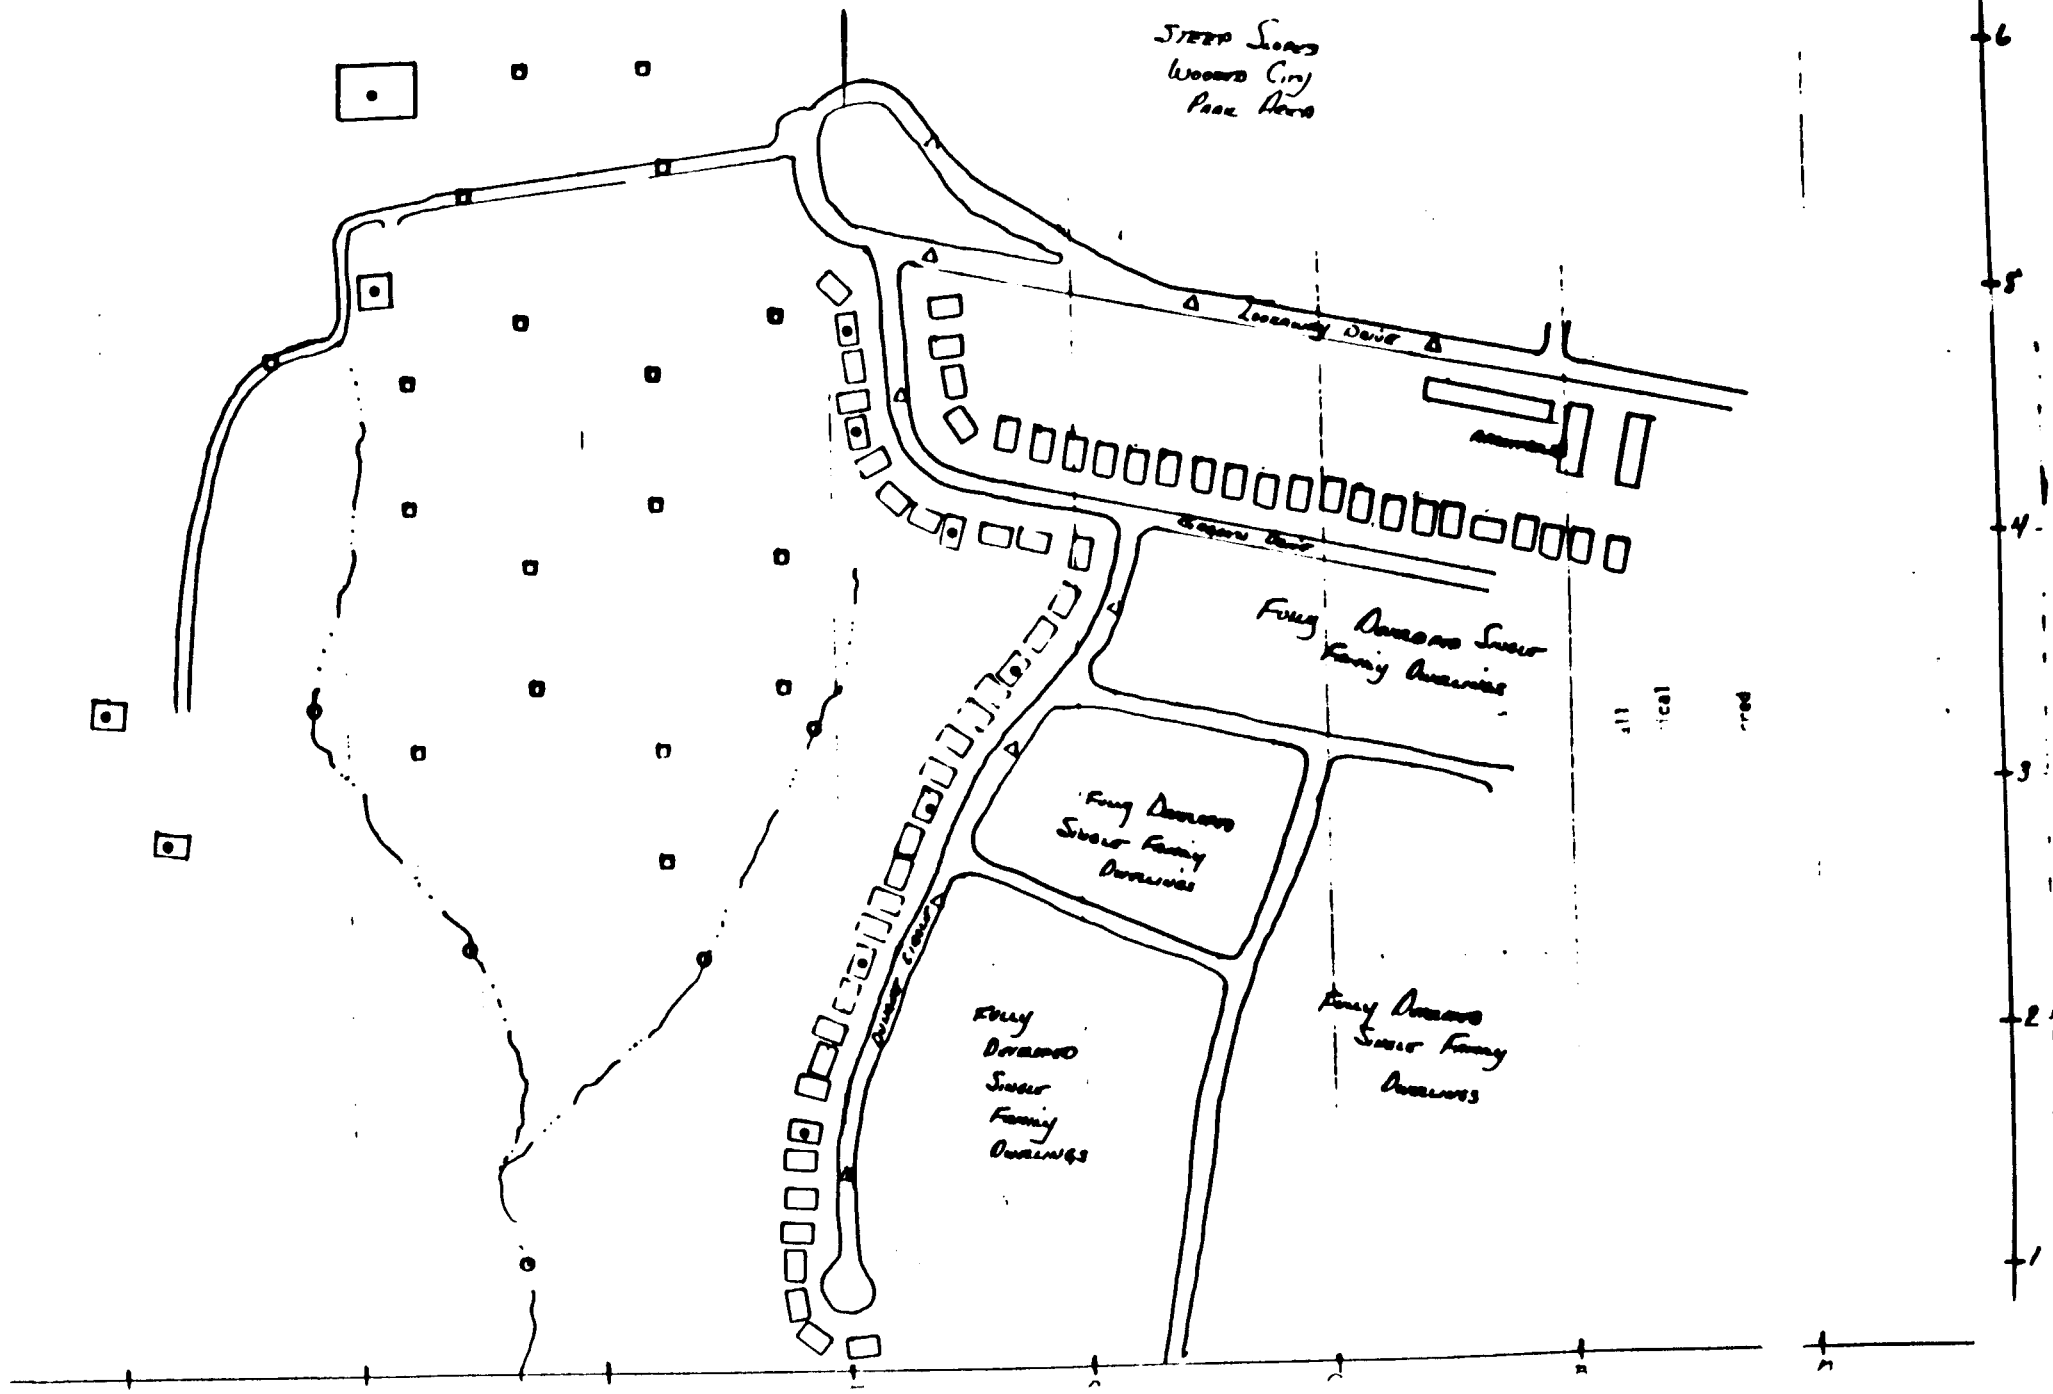
3. Residential Dust Samples - In areas where streets are not paved or significant human exposure may be possible, our practice is to collect residential dust from owners vacuum sweepers for analyses. For this site, approximately a dozen such samples are proposed around the site with tentative locations, pending contact with property owners, shown as small red circles inside the selected residences.

4. Drainage Samples - Downgradient drainage samples are collected from sediment deposits in stream channels draining the contaminated area. Five such samples are shown as open red triangles for this site. Each sample point represents collected sediments from a 100' stream reach bracketing the shown sample point on the sketch.

5. Yard Samples - Homes adjacent to the alleged sprayed area will have multipel (10) aliquot yard samples taken at 0 to 6" from the backyards to provide information in potential residential exposure for the hazard assessment to be done by health officials. Eight samples are shown for this purpose as small solid red rectangles.

Sample collection and safety procedures will remain identical to those described previously in study plan documents for previous phases of the St. Louis area dioxin investigations. The contaminated intensive area as shown by the open red rectangles grid will be considered as the "high hazard" or red zone for safety purposes and no personnel are to enter this area unless they are in full compliance with the site safety plan.

Sample series numbers for this site will be AP-15, all sample points will be identified for location purposes using grid points of the master site sketches as the principle locator guide. For example, the Blackard residence, northwest of the parking area will be identified as "Sample location F.80, 5.85, Dust, Blackard Residence, 11152 Lookaway Drive" and any other identifiers needed to fully characterize the sample.
